**Document type:** Investigation report

**Title:** Failure analysis of a compressed air container

**Items tested:** An aluminium compressed air container

**Customer:** Morini Competition Arm SA / CH-6930

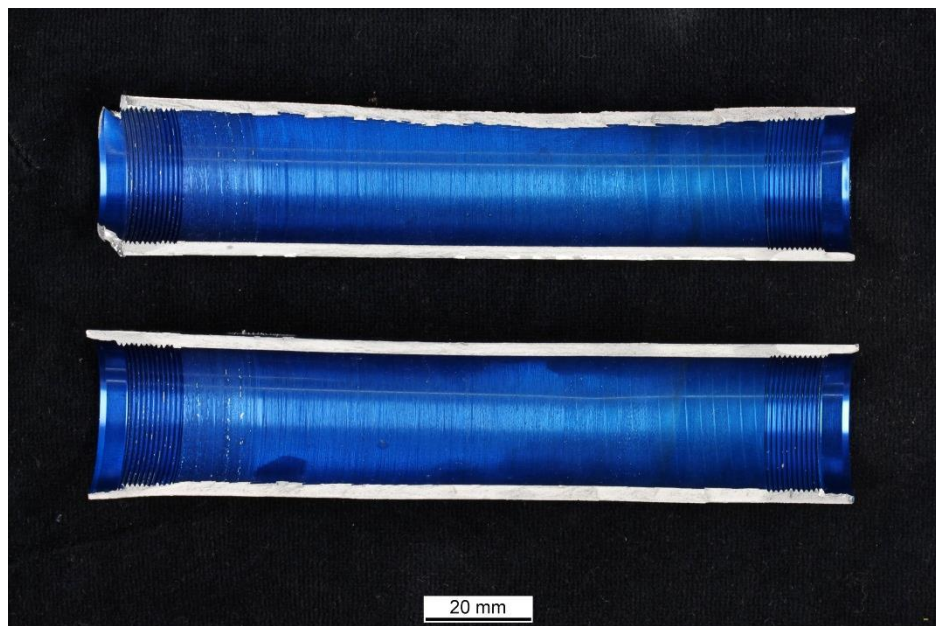
The item examined was a ruptured compressed air cylinder (Photos 1 to 2, Annex 1.1). According to information supplied by the customer, the material used was a high-tensile type 7075 aluminium alloy in heat treatment condition T6. The customer requested that a failure analysis examination be carried out to determine the cause of the rupture. This draft report presents the current status of our examinations as at 13 July 2018.

**Photo 1:** The broken specimen as delivered.

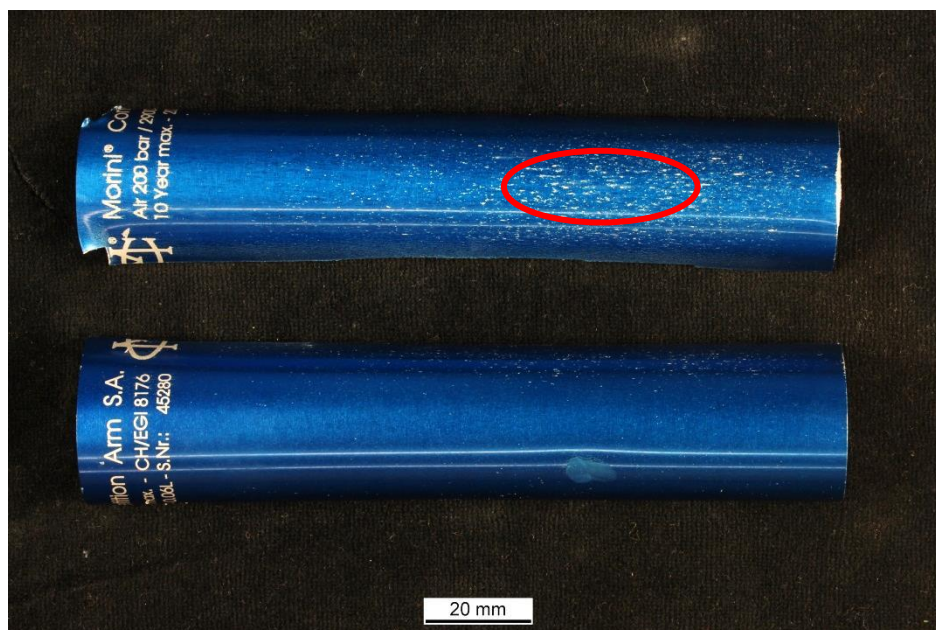
A conspicuous feature of the cylinder's surface was the presence of numerous corrosion scars. The area around the rupture on the container displayed a partly fissured fracture structure but with minimal deformation. There was a distinctive semi-elliptical structure which showed up as a bright shiny area. Consequently, it was possible to localise the fracture origination point to the outer side of the cylinder. The rest of the fracture area was of a uniformly grey colour (Photos 3 to 4, Annex 1.2).

**Photo 2:** The broken specimen as delivered. The areas of corrosion attack are conspicuous (circle).

Based on the condition of the surface, it can be stated that the outer side of the component had been exposed to a corrosive atmosphere containing chloride. The condition of the surface together with the numerous secondary cracks are indications of inappropriate handling and/or storage conditions. The cylinders had, however, been given a decoratively anodised coating, providing them with protection against the usual slight amounts of corrosion. But the cylinders were not designed to withstand the aggressive conditions which appeared to pertain here. Contact with an aggressive medium, which is essential for stress corrosion cracking to occur, can be prevented by appropriate handling and storage.

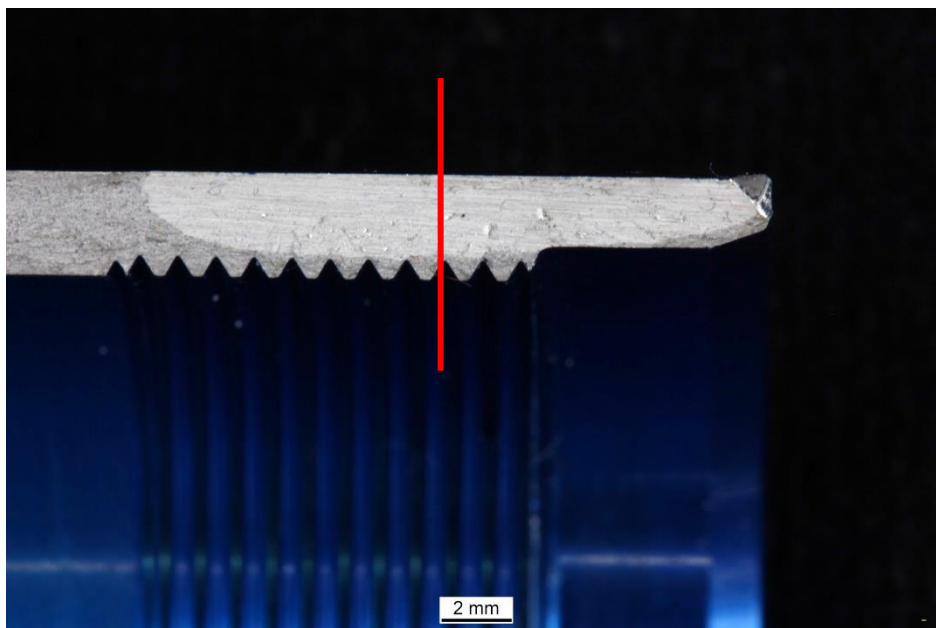
**Photo 3:** Close-up of the fracture area showing the bright semi-elliptical fracture origination zone. The section plane for the metallographic examination is indicated by the red line.

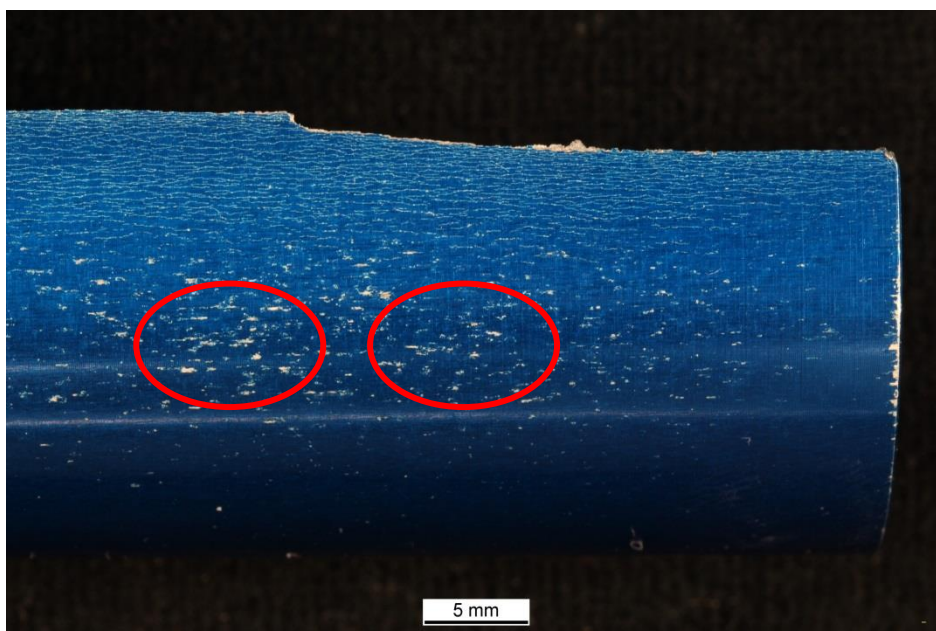
**Photo 4:** Side view of the cylinder with areas of corrosion attack (circles).

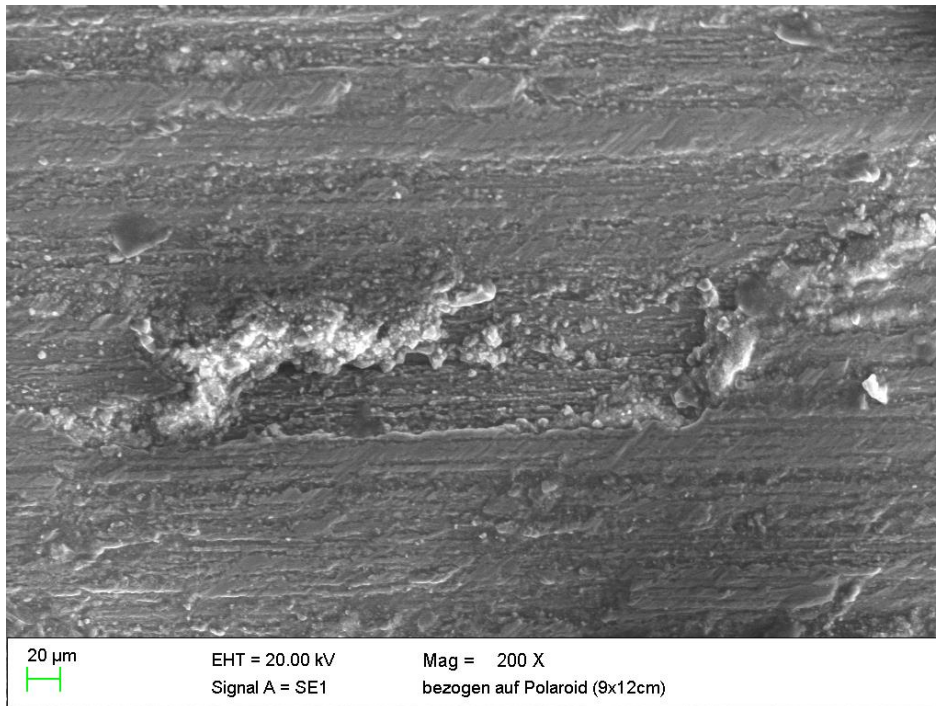
Under the scanning electron microscope, a smooth intergranular structure coated with corrosion products could be seen in the area of primary cracking. Secondary cracks could be detected on the surface in the fracture origination area. The final forced fracture exhibited the characteristics of a microductile forced rupture (Photos 5 to 9, Annexes 1.3 to 1.5).

**Photo 5:** SEM image of the broken specimen: fracture origination point. Fracture surface partly coated with corrosion products.

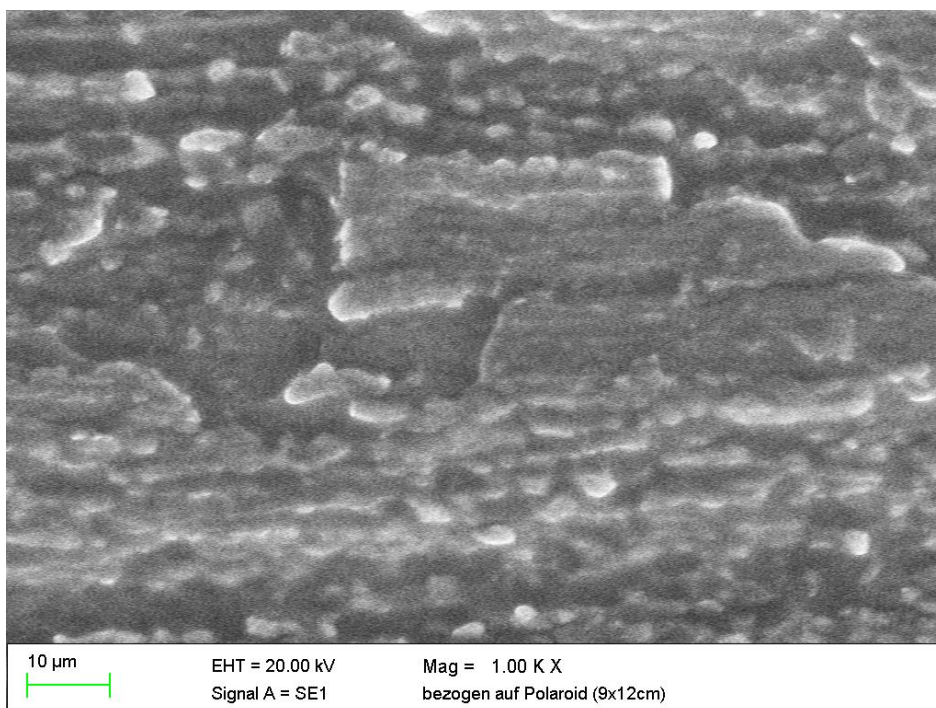
**Photo 6:** SEM image of the broken specimen: intergranular structure coated with corrosion products.

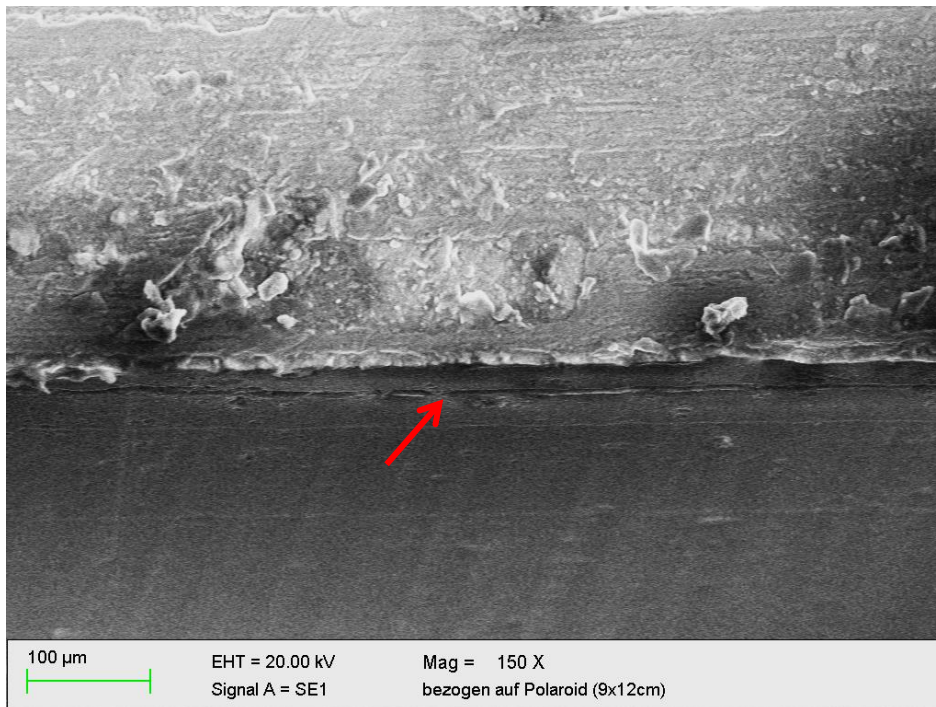
**Photo 7:** SEM image of the broken specimen: secondary crack (arrow) below the fracture origination point.

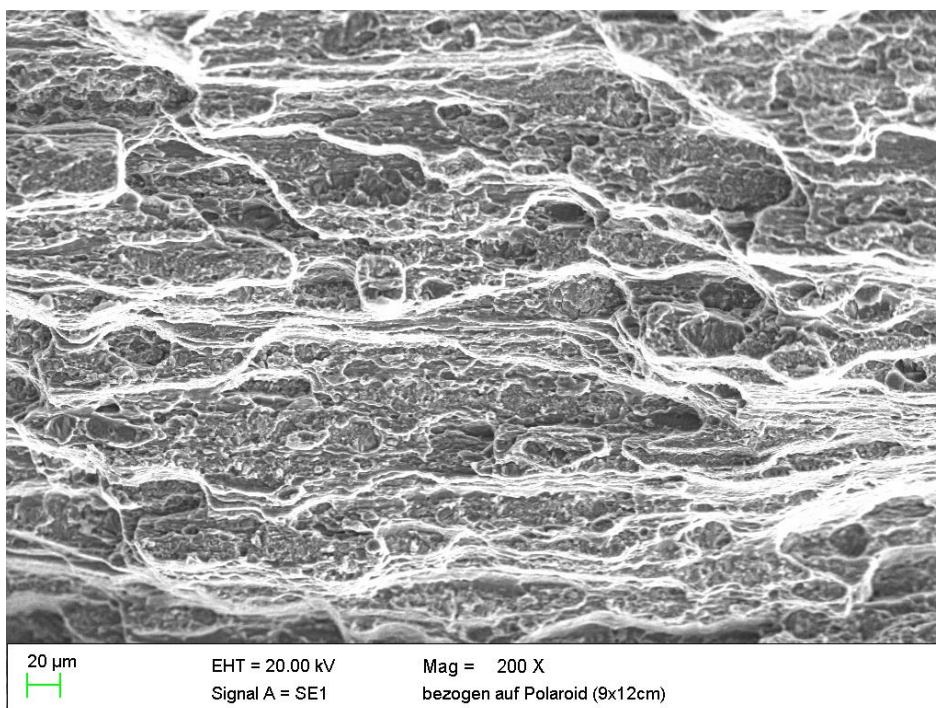
**Photo 8:** SEM image of the broken specimen: Final forced fracture; microductile fracture with dimples.

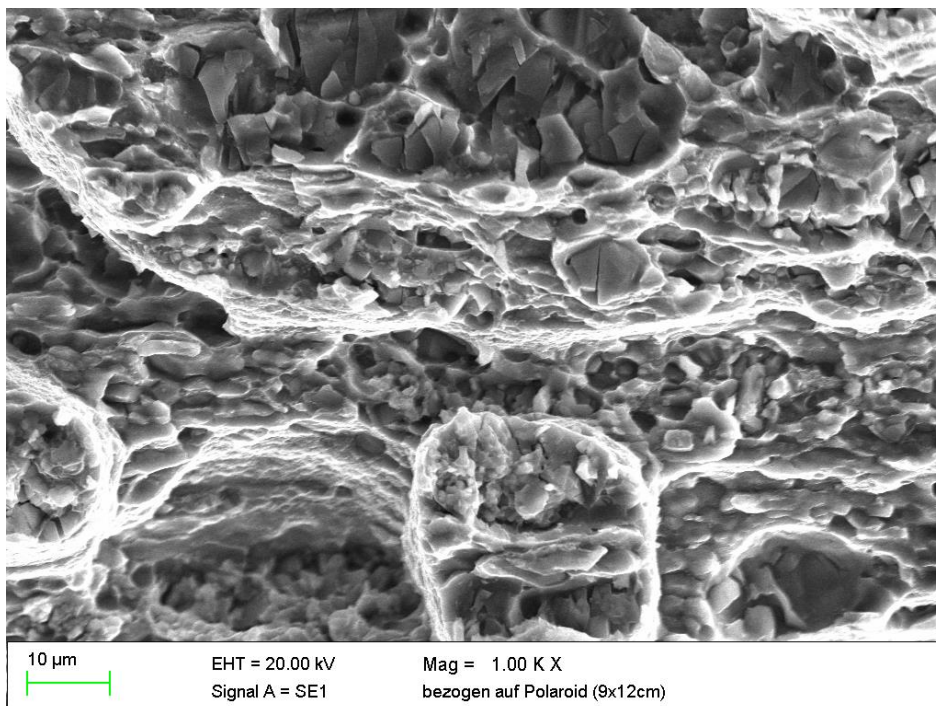
**Photo 9:** SEM image of the broken specimen: Final forced fracture; microductile fracture with dimples.

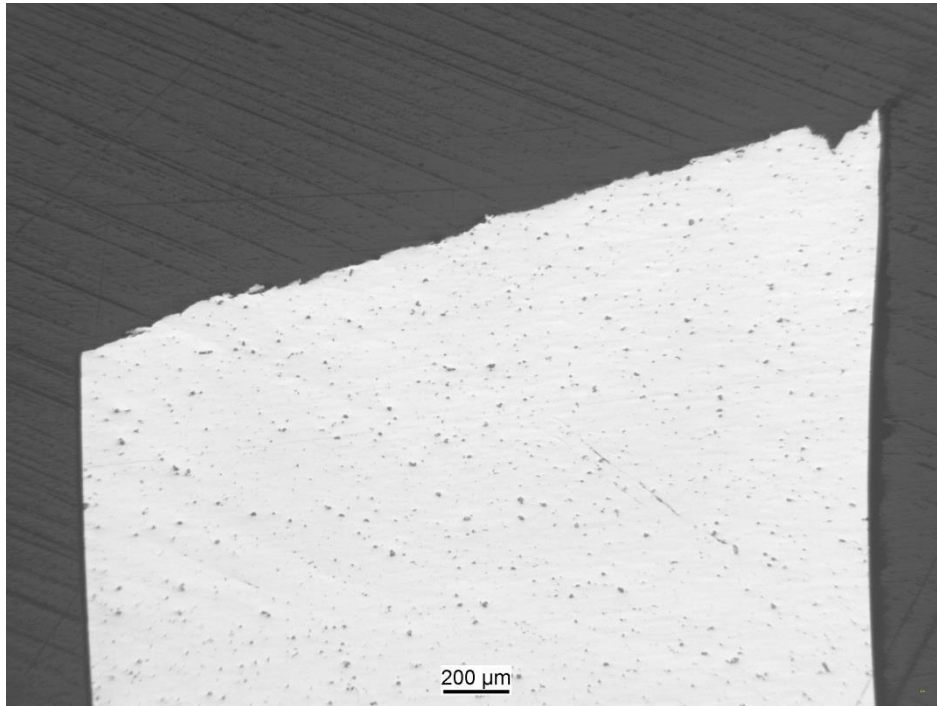
Branched crack systems emanating from the corrosion scars could be seen in the polished microsection. The etched microstructure displayed a compressed microstructure with intermetallic phases. The cracks very largely followed an intergranular path (Photos 10 to 13, Annexes 1.6 and 1.7).

**Photo 10:** The broken specimen; polished microsection, side view of the fracture surface.

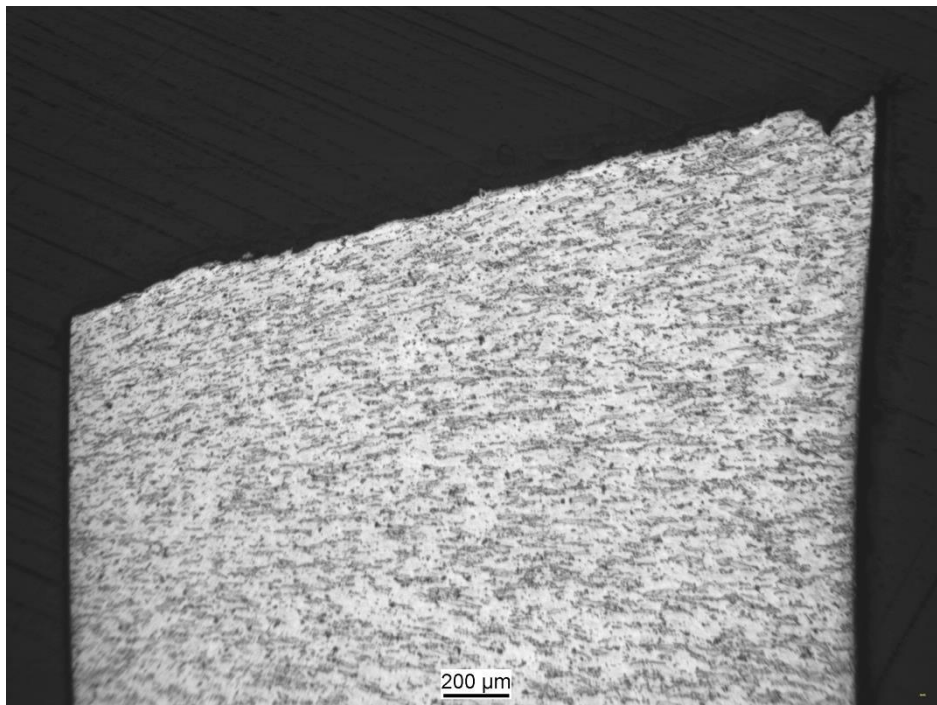
**Photo 11:** The broken specimen; etched microsection, side view of the fracture surface. A compressed microstructure can be seen.

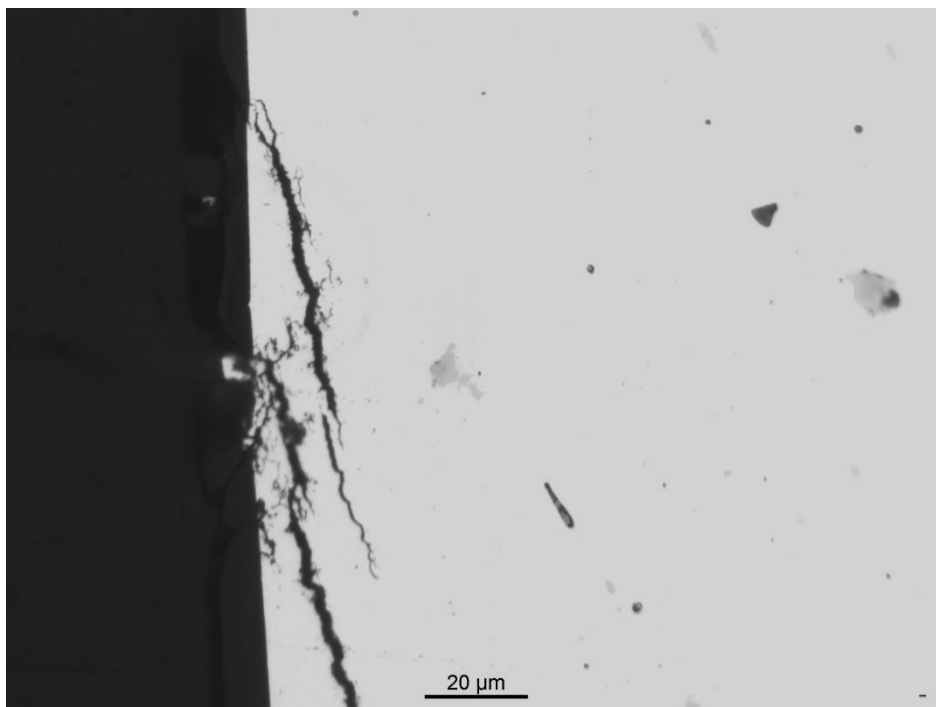
**Photo 12:** The broken specimen; polished microsection, illustrating a branched secondary crack emanating from a corrosion scar.

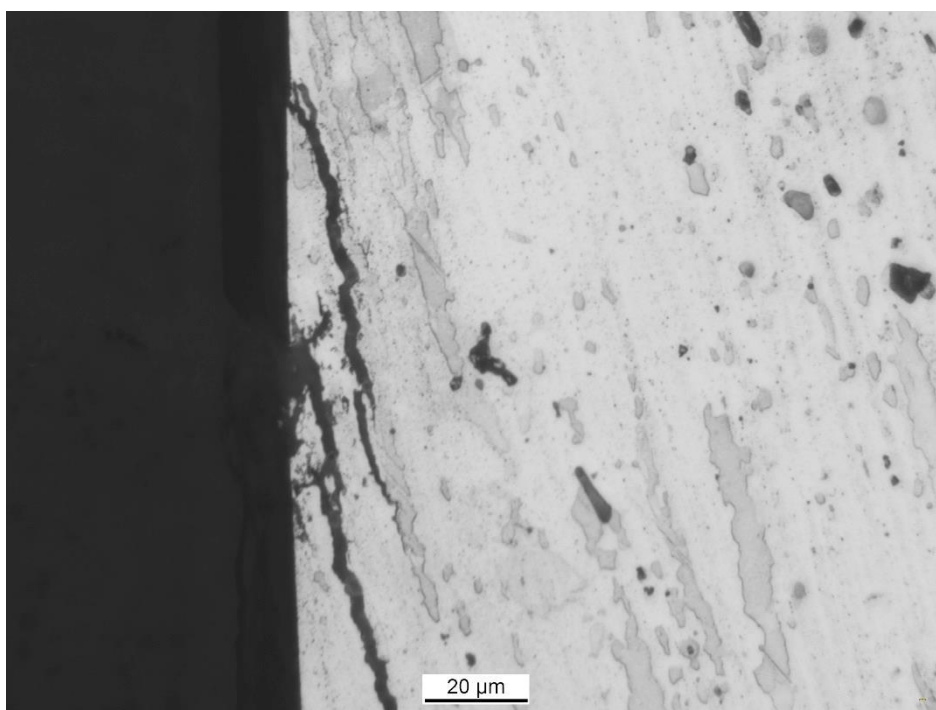
**Photo 13:** The broken specimen; etched microsection; intergranular crack pattern.

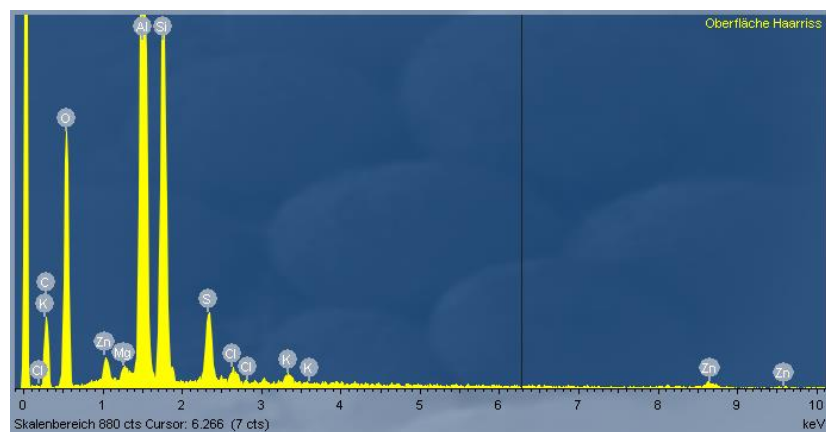
Energy dispersive X-ray identified chlorine in the corrosion products as the corrosion-inducing element (Spectrum 1, Annex 2.1).

**Spectrum 1:** Chloride as the corrosive substance on the surface of the aluminium cylinder.
